JUNE 1978

**NASA Technical Paper 1210**

# **Light Airplane Crash Tests at Three Flight-Path Angles**

**Claude B. Castle and Emilio Alfaro-Bou**  
*Langley Research Center*  
*Hampton, Virginia*

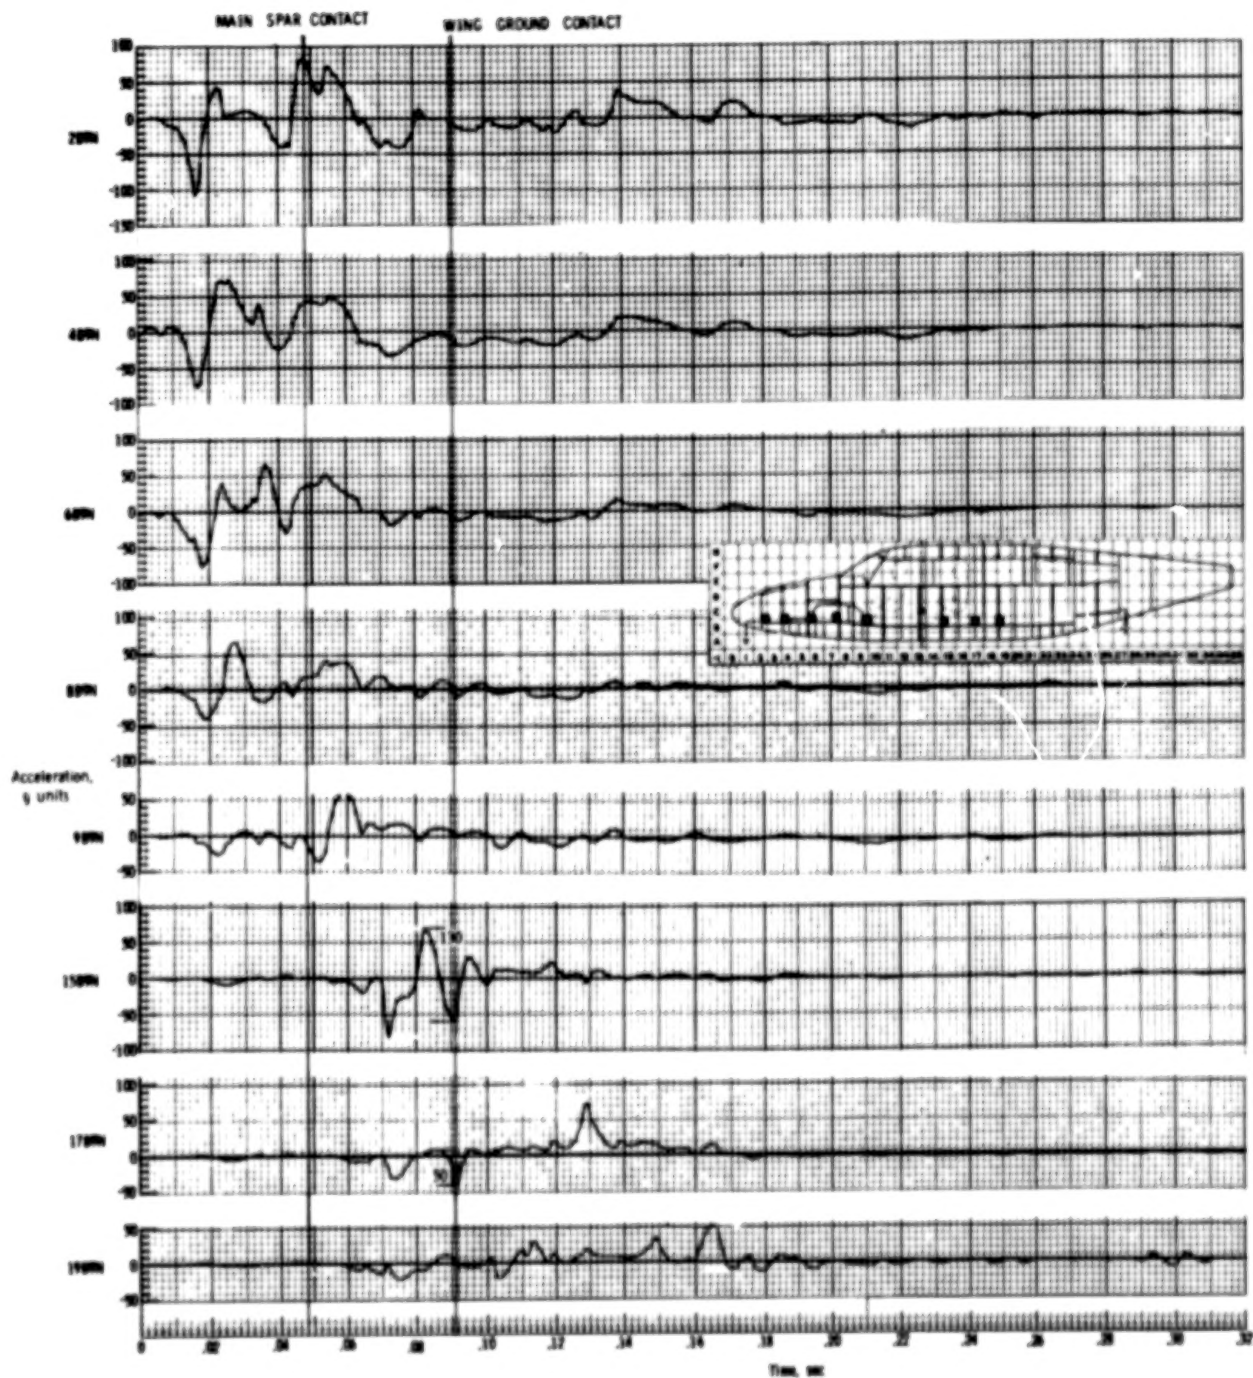
(a) -15° test specimen.

-15° test specimen. - In figure 18(a), eight acceleration time-history traces in the normal direction from the -15° impact are presented with timed events from photographic data superimposed on the traces for correlation and interpretation. The eight accelerometers are spaced along the floor beam of the airplane from the first nose frame (2B9N) to the door of the cabin (19B9N). The response of initial ground contact is felt immediately at the first frame (2B9N) and is seen to progress rearward to the instrument panel (9B9N), with diminishing intensity and with a slight time lag associated with the rear progression of the contact surface. The nose of the airplane exhibits high amplitude oscillatory behavior caused by the repeated sequence of negative accelerations. This oscillatory behavior is due to load transmission through structural failures and load build-up, thereby relieving load momentarily on undamaged structure and causing subsequent structural deceleration loading. This cycle is repeated as various structural elements are loaded and successively fail. Main spar ground contact (0.048 sec) produces a downward force in the nose of the airplane (positive acceleration) and signals the initiation of cabin compartment excitation. Acceleration peaks in the cabin compartment are a maximum in the vicinity of the main spar and diminish progressively from that point rearward. At 0.091 sec (fig. 18(a)) the loss of wing dihedral angle and wing ground contact occurs, thus resulting in the twisting of the main spar. At this time, peak-to-peak accelerations of 130g and 50g are produced in the first-passenger aisle seat legs (15B9N and 17B9N).

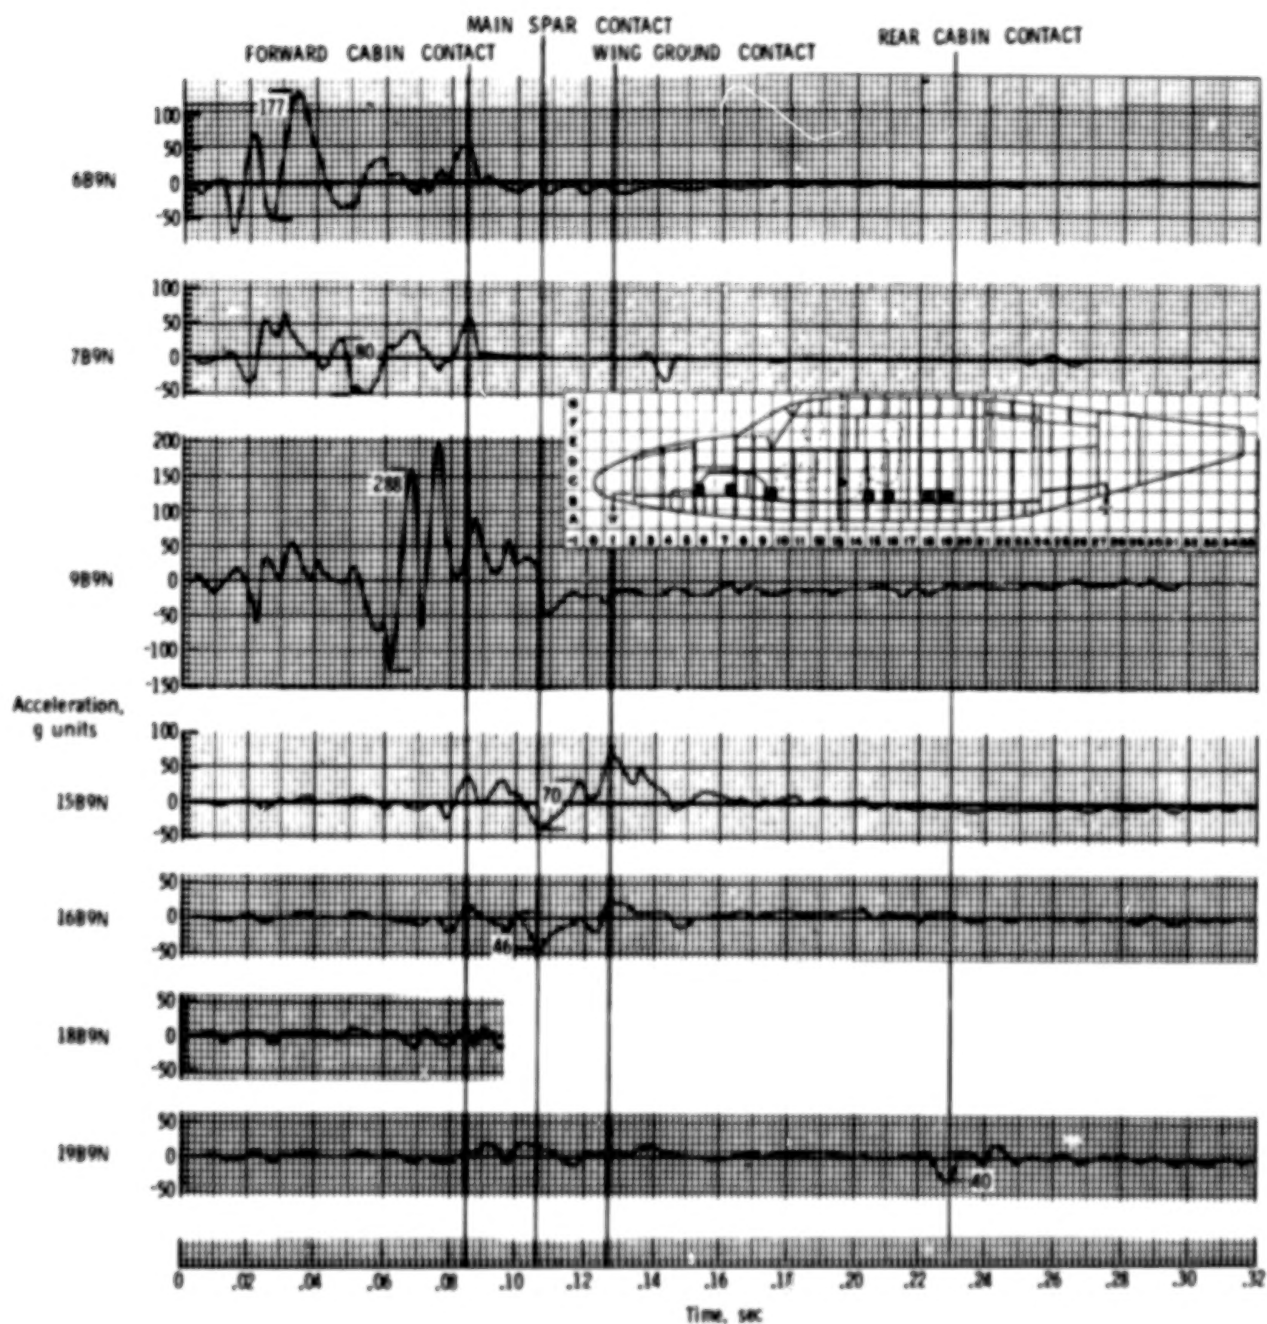
(b)  $-30^\circ$  test specimen.

-30° test specimen. - Seven normal accelerations along the floor beam for the -30° impact are shown in figure 18(b). Accelerometer locations are similar to those of the -15° impact (fig. 8), except for the removal of the accelerometer from the middle of the luggage compartment in the nose of the airplane (4B9N at -15° impact). The response at initial ground contact in the nose of the airplane is severe and is seen to progress rearward to the instrument panel (9B9N) with diminishing intensity. The maximum peak-to-peak acceleration at the fire wall (9B9N) is 190 percent higher for the -30° impact than for the -15° impact.

Severe local accelerations in the vicinity of the floor under the instrument panel (9B9N) indicate structural vibrations (0.065 sec). The ground contact is seen to progress from the nose of the airplane rearward through the cabin area. The intensity of the accelerations in the cabin area increases markedly as the cabin first begins to make contact with the ground (0.085 sec) and the door begins to open. The main spar contact occurs at 0.107 sec and coincides with a large peak-to-peak acceleration of approximately 70g (15B9N) and 46g (16B9N) in the first-passenger seat; also, it causes loss of an accelerometer (18B9N) in the front aisle leg of the third-passenger seat. A second acceleration pulse occurs in the rear of the third-passenger seat (19B9N) when

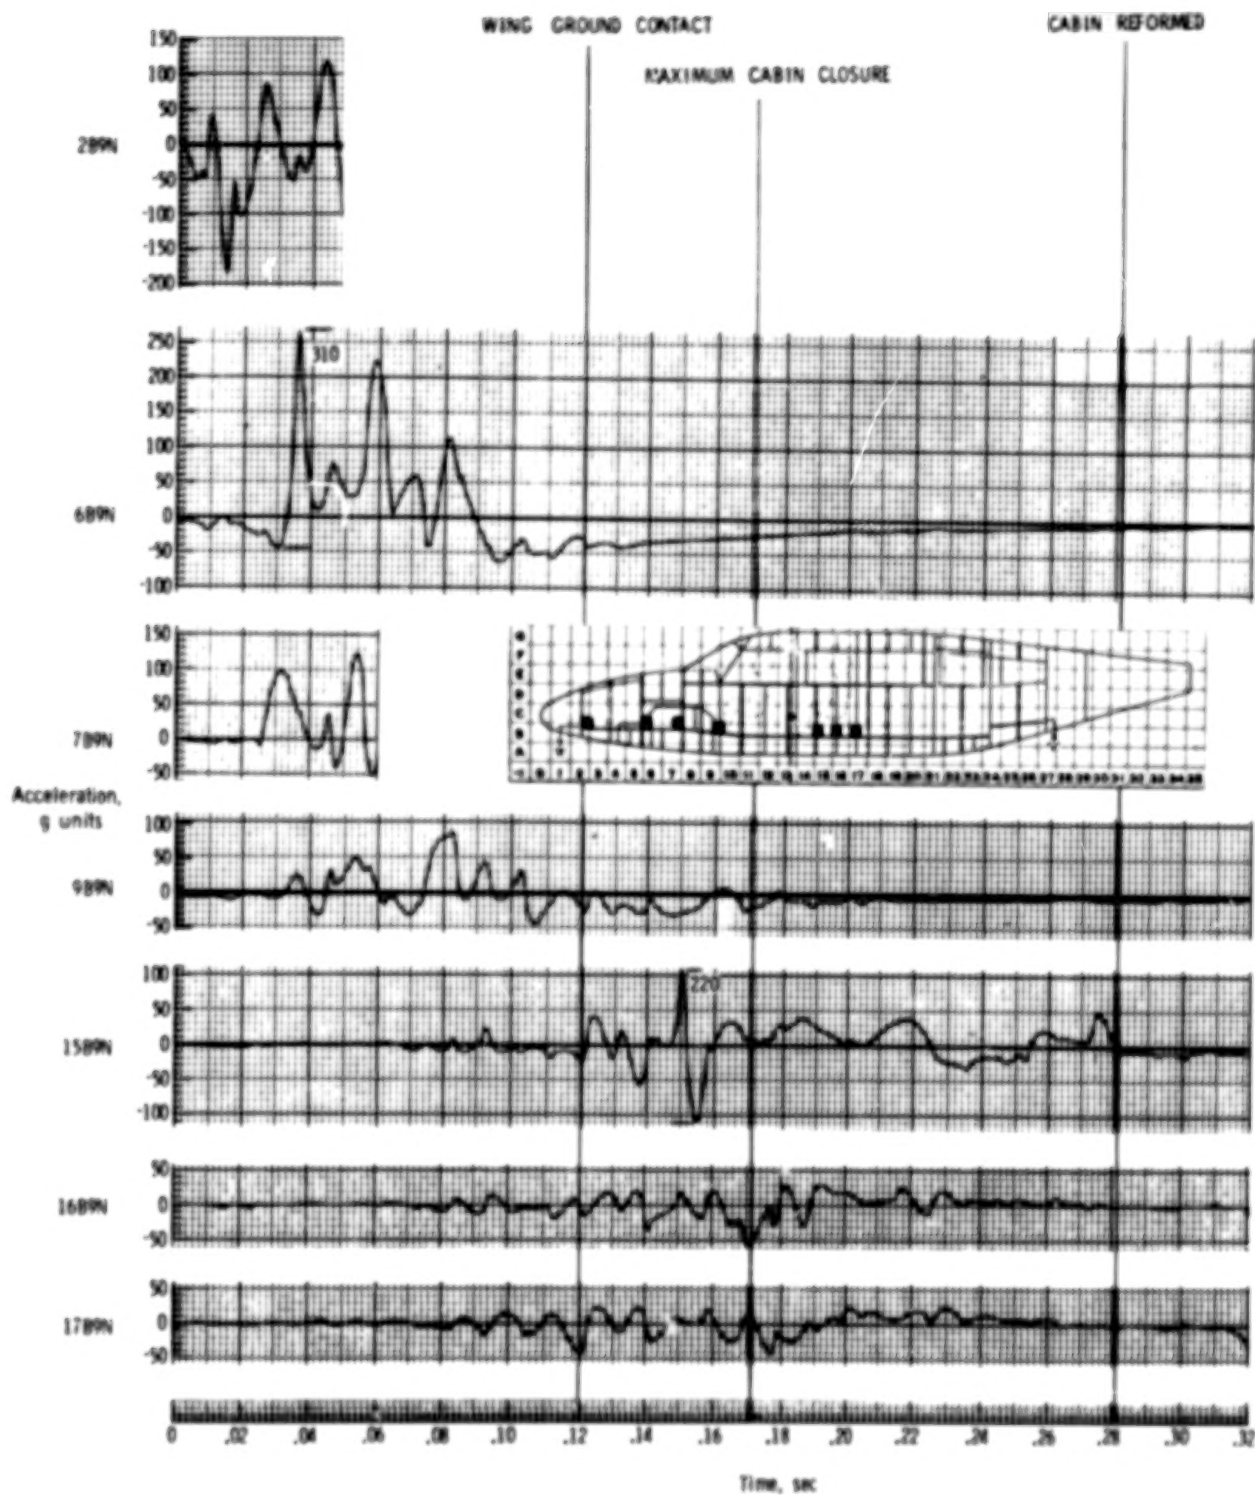
(c) -45° test specimen.

-45° test specimen.- Seven normal accelerations along the floor beam for the -45° impact are shown in figure 18(c). The accelerometer locations are similar to those of -30° impact (fig. 8). The response at initial ground contact in the nose of the airplane is most severe for the -45° impact; in fact, peak-to-peak accelerations as high as 310g are induced. On moving rearward after the progression of the impact pulse, the magnitudes of the acceleration decrease as some of the impact energy is absorbed by the nose structure and less difference in magnitude is evident between the -15°, -30°, and -45° acceleration traces in the cabin area of the three test specimens. Overall, the duration of accelerations is shorter and less severe in the -15° impact than in the -30° impact or in the -45° impact. (See figs. 18(a), 18(b), and 18(c).)

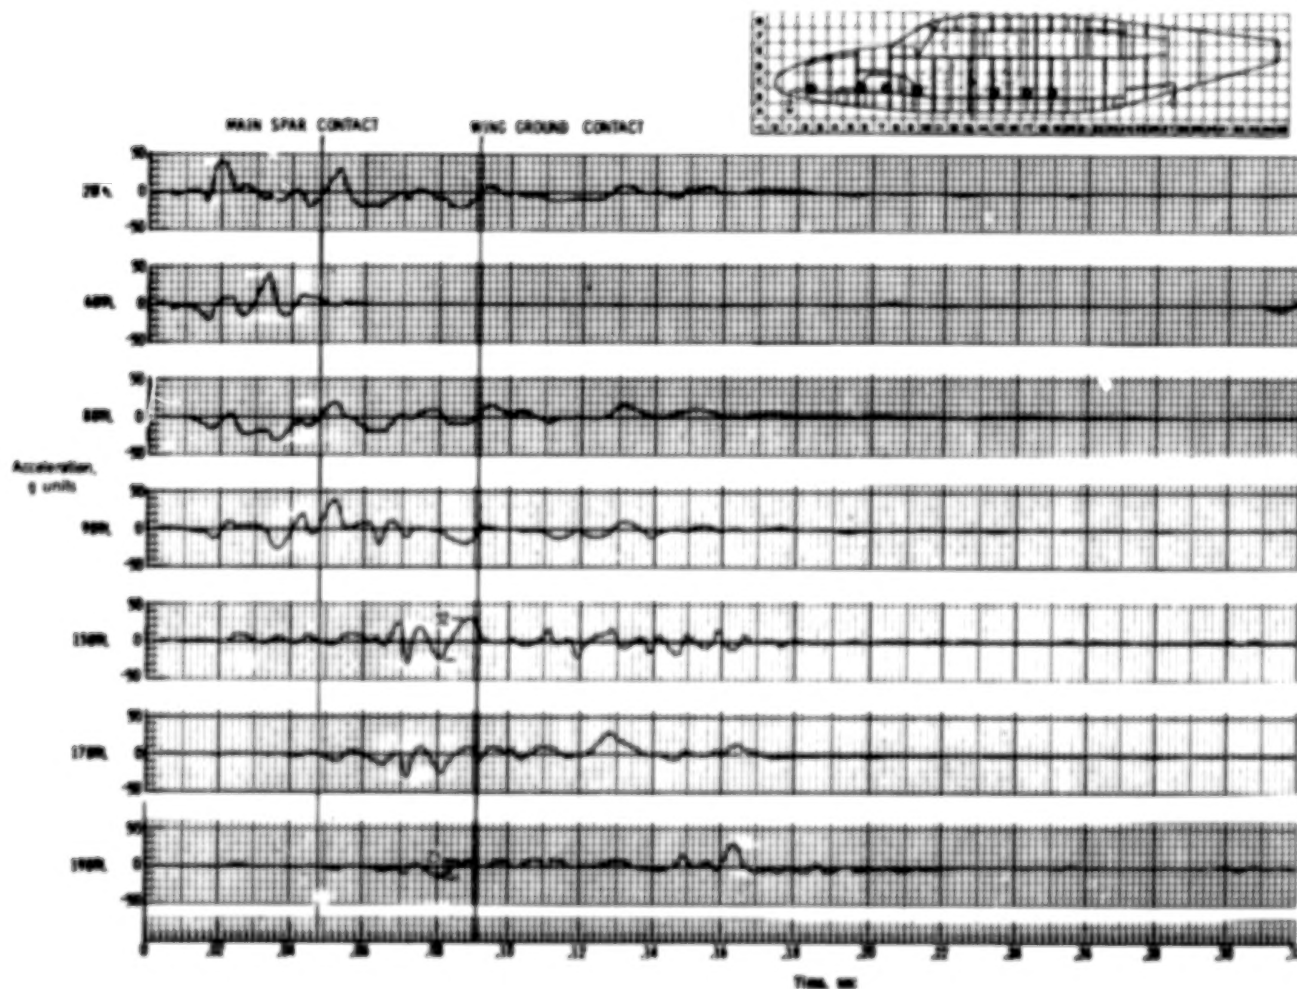
(a)  $-15^\circ$  test specimen.

In figure 19, time histories of fuselage floor-beam longitudinal accelerations are presented for the -15°, -30°, and -45° test specimens, with timed events from photographic data superimposed on the traces for correlation and interpretation.

-15° test specimen.- Seven accelerometers (fig. 19(a)) are spaced along the floor beam of the airplane from the first nose frame (2B9L) to the rear of the passenger seat (19B9L). The response at initial ground contact is felt immediately at the first frame (2B9L), and contact progresses rearward to the instrument panel (9B9L) with diminishing intensity but with about half the acceleration magnitudes experienced in the normal direction. Similarly, a characteristic high-amplitude oscillatory behavior in the nose of the airplane in the vicinity of the main spar is again evident for the longitudinal accelerations as for the normal accelerations. Wing ground contact (second impact) is shown at 0.091 sec. The time at which fuselage separation occurred (across the cabin roof in the vicinity of the main spar) coincides with the positive acceleration peak in 17B9L and 19B9L at 0.164 sec.

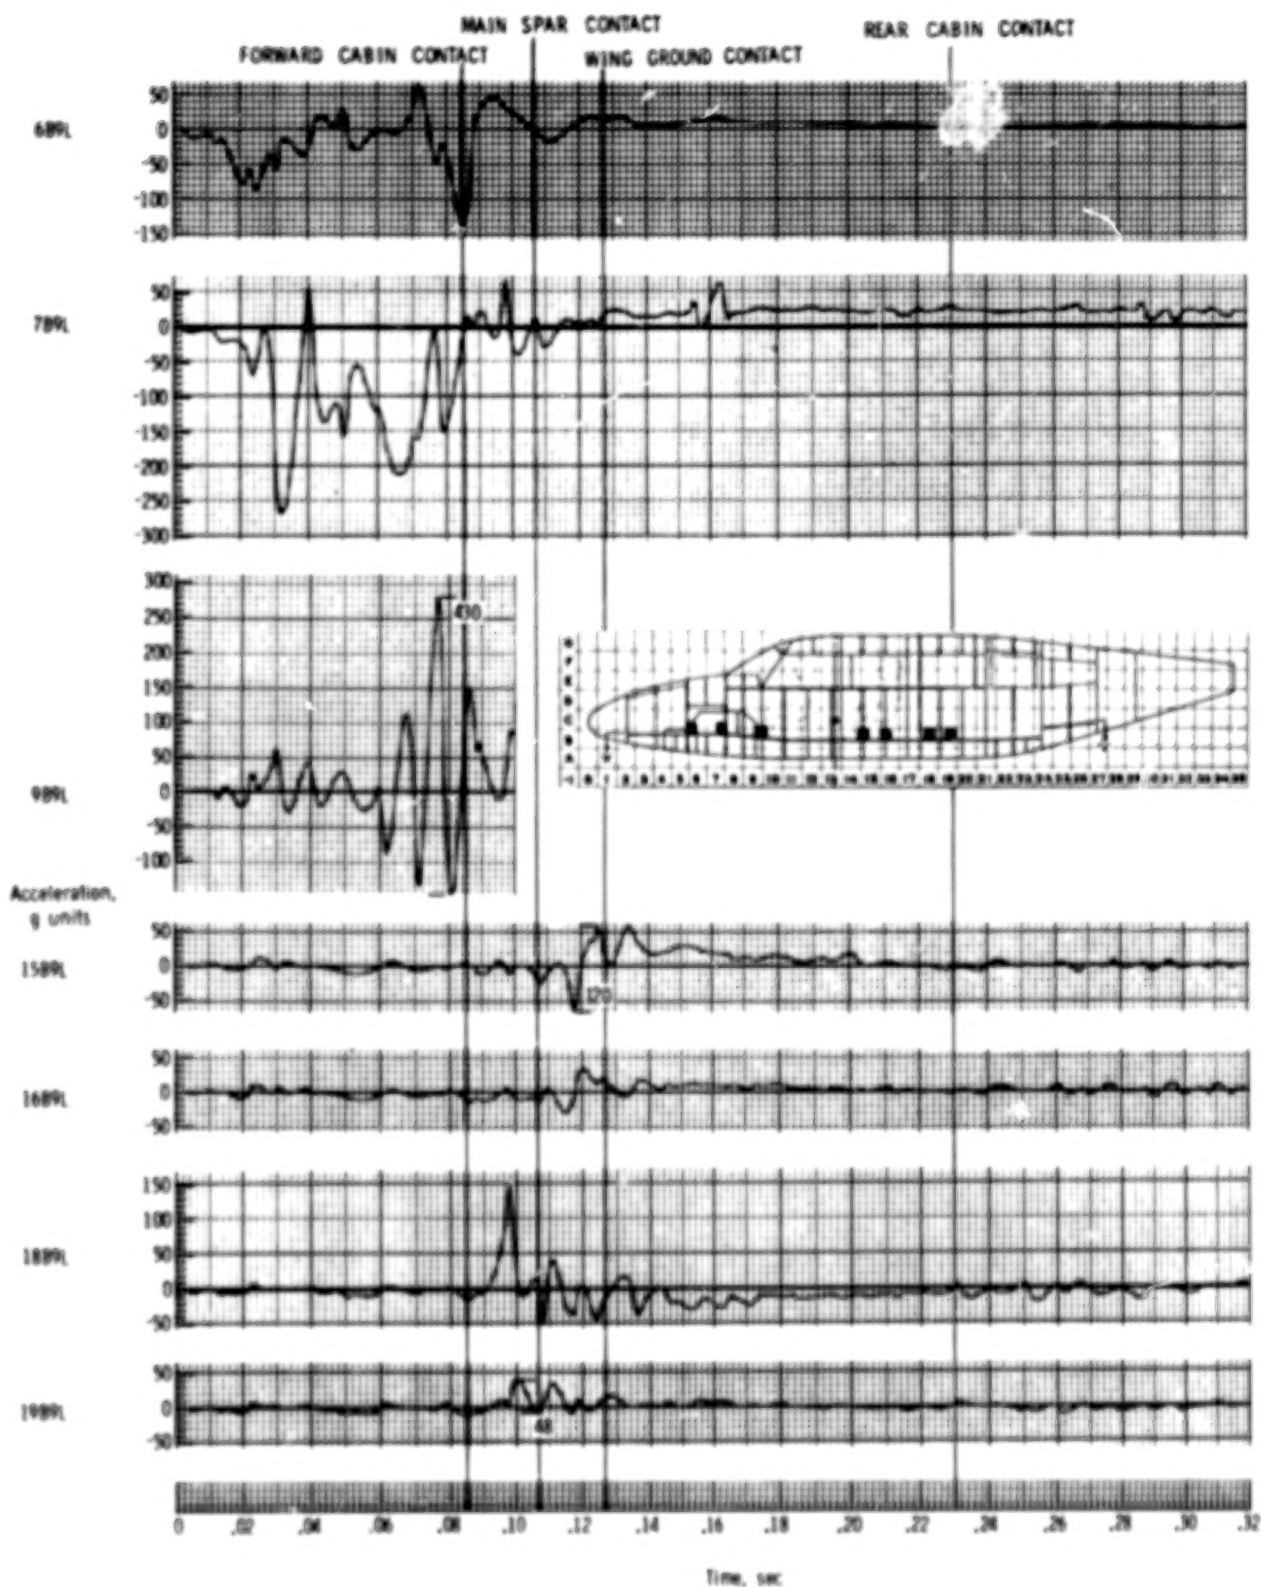
(b)  $-30^{\circ}$  test specimen.

-30° test specimen.- There are seven longitudinal accelerometer locations along the floor beam in the -30° impact test. The additional accelerometer location 18B9L was added when a passenger and seat were placed in the third-passenger position (fig. 7). The longitudinal accelerations for the -30° test specimen are shown in figure 19(b). The accelerometer below the instrument panel (9B9L) shows a peak-to-peak acceleration 340 percent greater for the -30° test specimen than for the -15° test specimen. The longitudinal peak-to-peak accelerations in the cabin area (15B9L to 19B9L) show an increase of approximately 130 percent over the -15° cabin accelerations. The change in flight-path angle has much greater effect on the nose to fire wall portion of the airplane than in the passenger compartment. The third-passenger seat begins to deform, as determined from motion-picture data at wing ground contact.

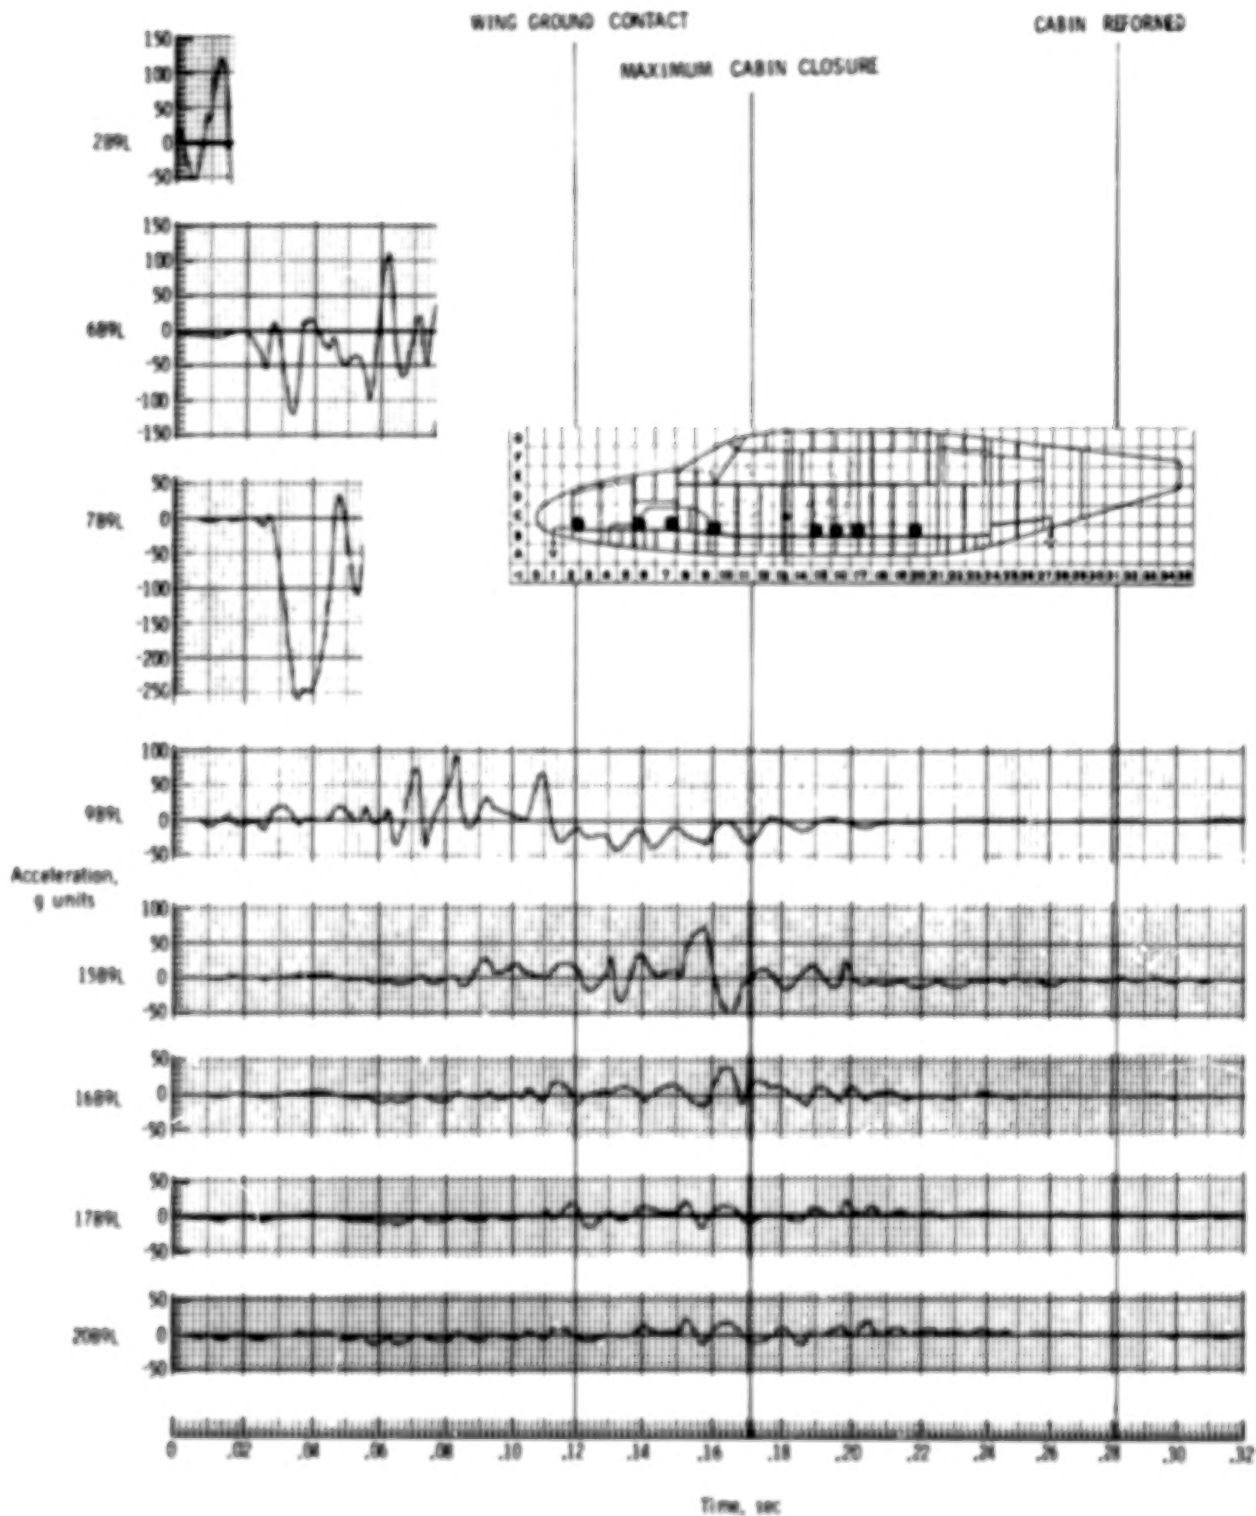
(c) -45° test specimen.

-45° test specimen.- In figure 19(c), eight longitudinal acceleration traces along the floor beam for the -45° test specimen are presented. The additional accelerometer location 20B9L was added when a passenger and seat

were placed in the third-passenger position (fig. 7). The magnitude of the longitudinal acceleration from the nose to the fire wall is about the same for the  $-45^\circ$  test specimen as for the  $-30^\circ$  test specimen. The longitudinal accelerations in the cabin area are also comparable to those of the  $-30^\circ$  test specimen, thus indicating that severe structural deformations, which limit the magnitudes of the accelerations, are taking place. Also evident are inconsistencies in individual acceleration traces at approximately the same fuselage location - 9B9L and 18B9L at  $-30^\circ$  and 9B9L and 17B9L at  $-45^\circ$  - with much higher accelerations at  $-30^\circ$ . These inconsistencies can be attributed to severe local structural failures changing the character of the local response. Wing ground contact at 0.120 sec to maximum closure of the cabin interior at 0.171 sec corresponds to the maximum longitudinal accelerations in the cabin interior with the maximum longitudinal acceleration occurring near maximum cabin closure (0.158 sec). After maximum cabin closure, the cabin began to reform as the airplane tail rotated to a horizontal position and continued its horizontal slide-out for approximately 30 m.

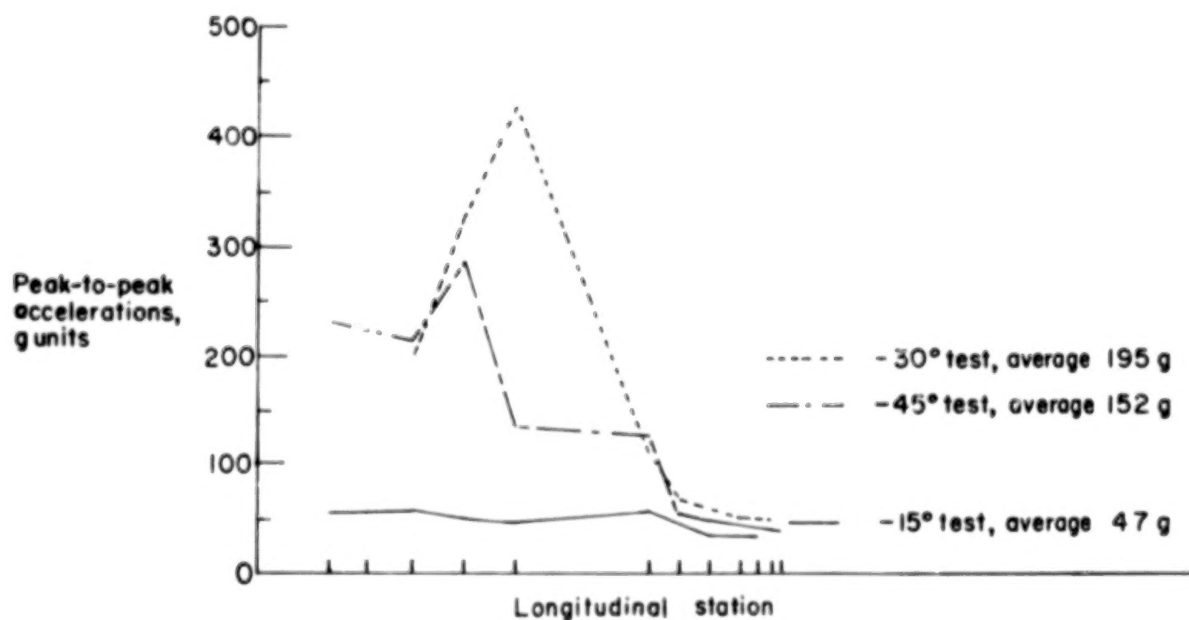
Figure 20.- Peak-to-peak accelerations along floor beam.

For the  $-15^\circ$  test specimen, the normal peak-to-peak acceleration levels (fig. 20(a)) were more than twice the longitudinal acceleration levels (fig. 20(b)). This was due to higher decelerations in the normal direction when the airplane contacted the impact surface and abruptly stopped the motion in that direction. However, after initial impact in the longitudinal direction, the airplane skidded for some distance and then came to a stop; this long skid distance contributed to lower longitudinal deceleration forces. In figure 20(b) the longitudinal levels are shown to be nearly constant for the entire length of the floor beam, thus indicating little floor-beam deformation for the  $-15^\circ$  test specimen but severe structural collapse and floor-beam deformations for the  $-30^\circ$  and  $-45^\circ$  test specimens. The effect of changes in flight-path angle

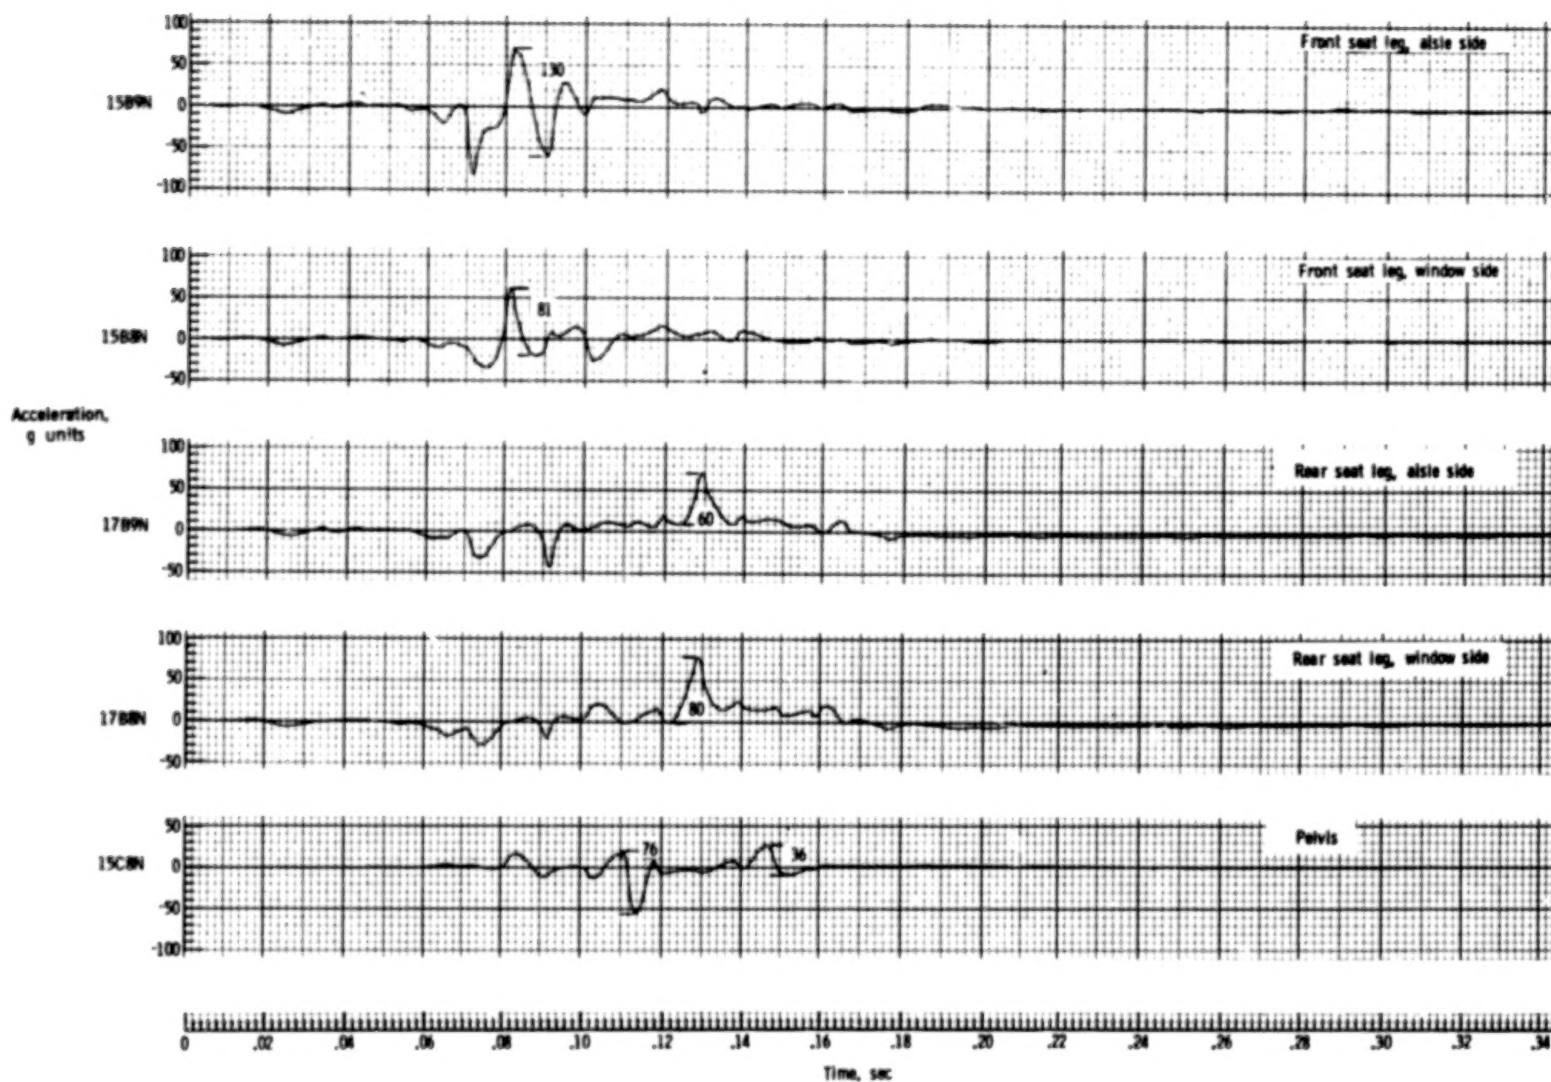
Figure 21.- Normal accelerations on floor and on dummy pelvis at first-passenger location.

Normal accelerations at  $-15^{\circ}$ . Figure 21(a) shows the normal accelerations for the  $-15^{\circ}$  test specimen. Peak-to-peak accelerations of 130g and 81g were recorded on the floor under the two front seat legs at the first-passenger location, and accelerations of 76g (58 percent of 130g) were recorded in the pelvis approximately 0.025 sec later. The peak-to-peak accelerations under the rear seat legs were 60g and 80g and corresponded to a 36g pulse (45 percent of 80g) on the pelvis - again with a delay of approximately 0.025 sec.

Effects of normal accelerations. The pelvis peak-to-peak accelerations in the  $-15^{\circ}$ ,  $-30^{\circ}$ , and  $-45^{\circ}$  test specimens were 76g (fig. 21(a)), 40g (fig. 21(b)),

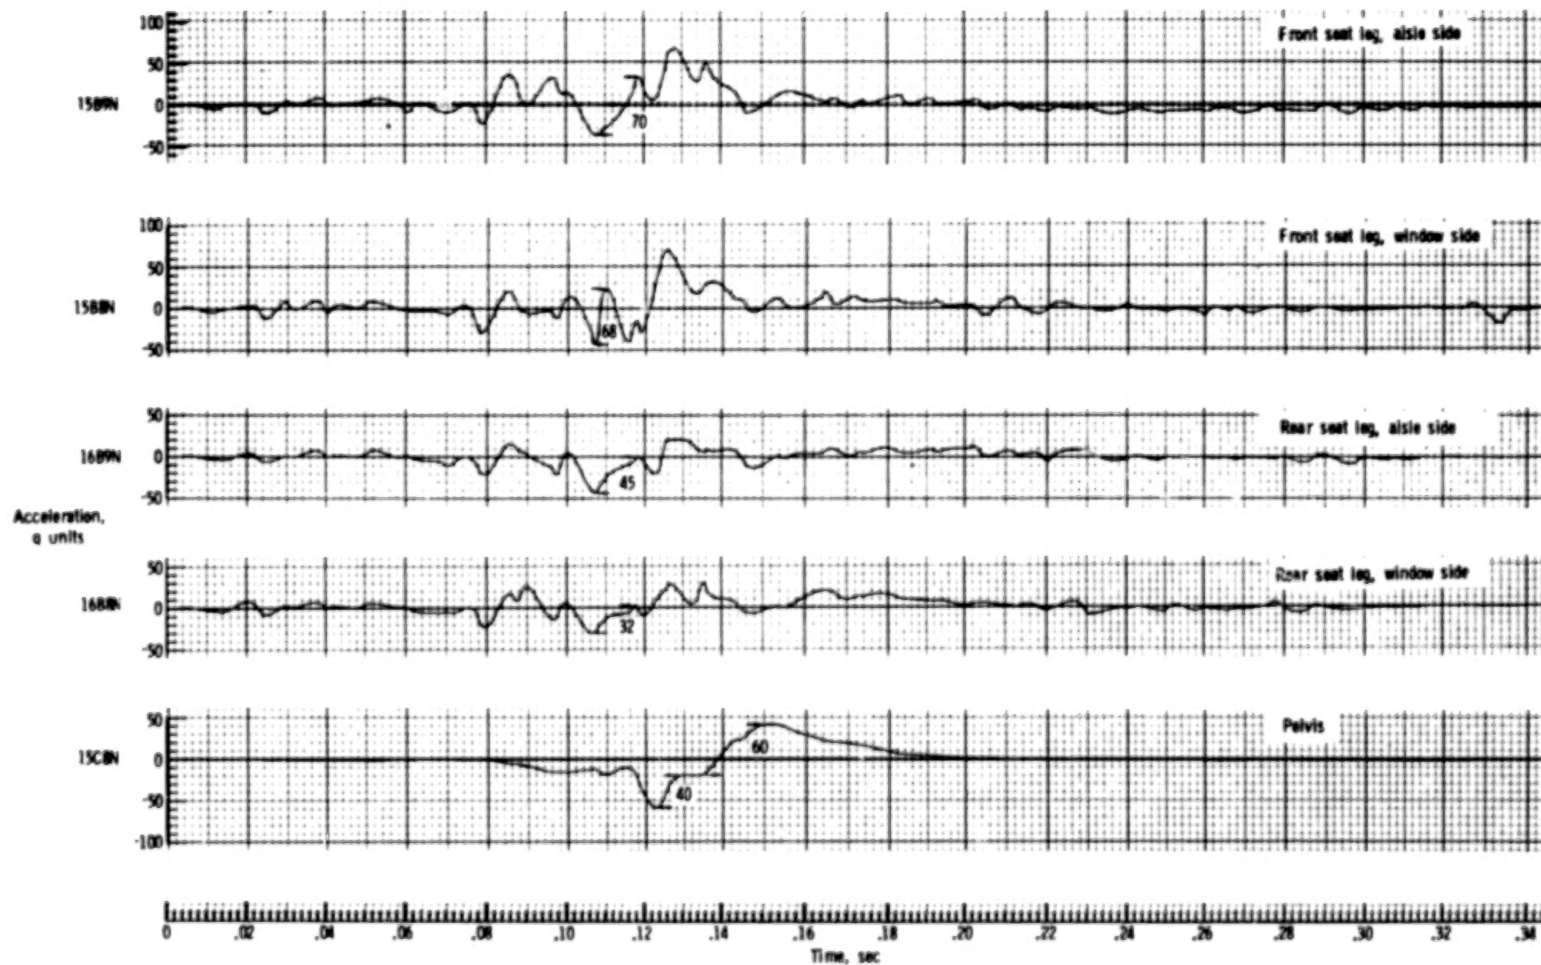
Figure 21.- Continued.

Normal accelerations at  $-30^{\circ}$ . Figure 21(b) shows the normal accelerations for the  $-30^{\circ}$  test specimen. Peak-to-peak accelerations of 70g and 68g were recorded on the floor under the two front seat legs and 45g and 32g under the two rear seat legs. The acceleration on the pelvis was recorded at 40g (15 percent of 70g) approximately 0.02 sec later.

The  $-30^{\circ}$  test specimen was the only one in which the restraint system of the first passenger was instrumented with load cells. The positive (downward) peak-to-peak accelerations of 60g (fig. 21(b)) in the pelvis corresponded to a 5.3-kN tensile force in the shoulder harness (see appendix fig. A3(f)) when the occupant's relative motion with respect to the seat was stopped by the restraint system.

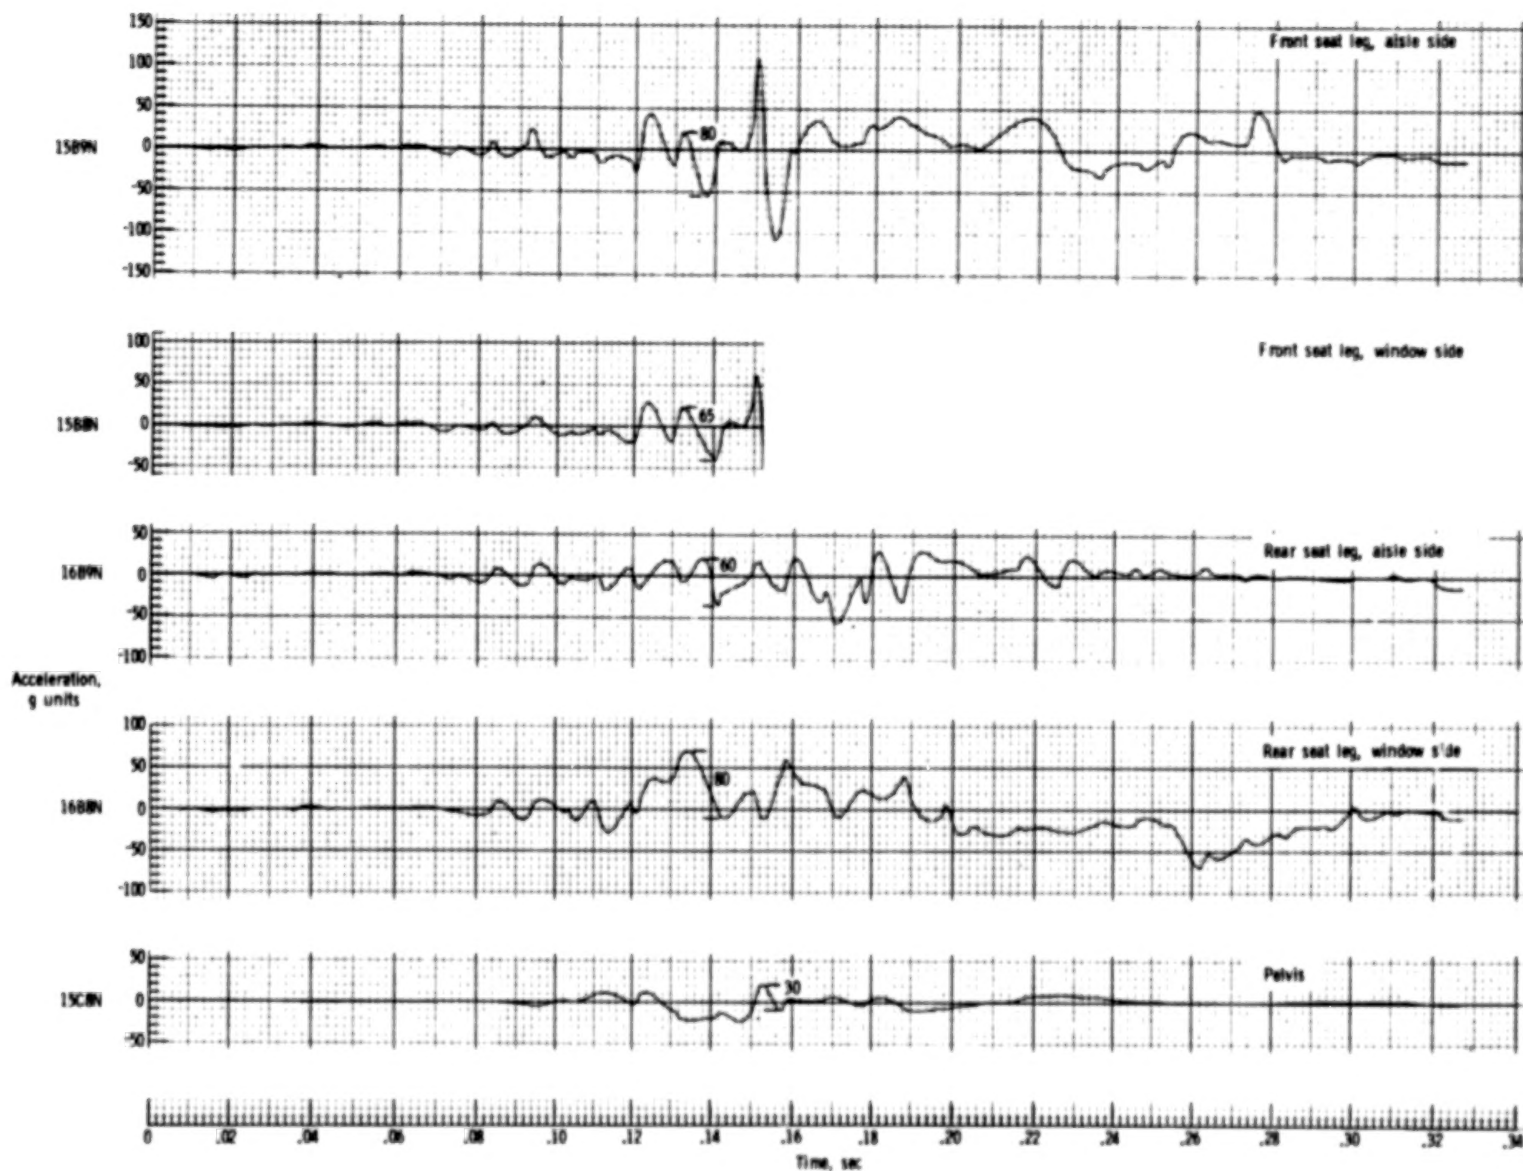
Figure 21.- Concluded.

Normal accelerations at  $-45^{\circ}$ . Some unusual airplane crash behavior was exhibited by the  $-45^{\circ}$  test specimen during impact. First, the nose of the airplane impacted and crushed progressively to the fire wall while the remaining portion of the fuselage maintained its  $-45^{\circ}$  flight-path angle, thus eliminating the livable volume in the cabin. This behavior was followed by a downward rotation and a reforming of the fuselage immediately thereafter. The resulting accelerations (fig. 21(c)) on the floor and in the pelvis of the first passenger lacked the smoothness and well-defined pelvic pulse of the  $-15^{\circ}$  and  $-30^{\circ}$  test specimens. Nevertheless, peak-to-peak accelerations on the floor were 80g and 65g next to the front seat legs and 60g and 80g next to the rear seat legs. The peak-to-peak acceleration on the pelvis was 30g (38 percent of 80g), which occurred at about 0.015 sec later. The seat deformed, absorbing some of the impact energy and reducing the pelvic accelerations.

and 30g (fig. 21(c)), respectively. The 76g acceleration reflects the effect of cabin slapdown on the impact surface. A positive 60g peak-to-peak pulse was due to the effect produced by the dummy lifting off the seat against the restraint system. The 30g acceleration reflects the effect energy absorption plays in reducing load transmission. A greater total seat deformation was obtained in the  $-45^\circ$  test specimen than was obtained in either the  $-15^\circ$  or  $-30^\circ$  test specimens. This situation suggests that accelerations experienced in aircraft crashes are limited by the eventual collapse of the surrounding structure. Unfortunately, this structural collapse may also be accompanied by the loss of a livable volume within the cabin area, affecting the survivability of the occupant. In a crashworthy design, the structural collapse would be controlled to produce maximum energy absorption and still maintain livable volume in the cabin.

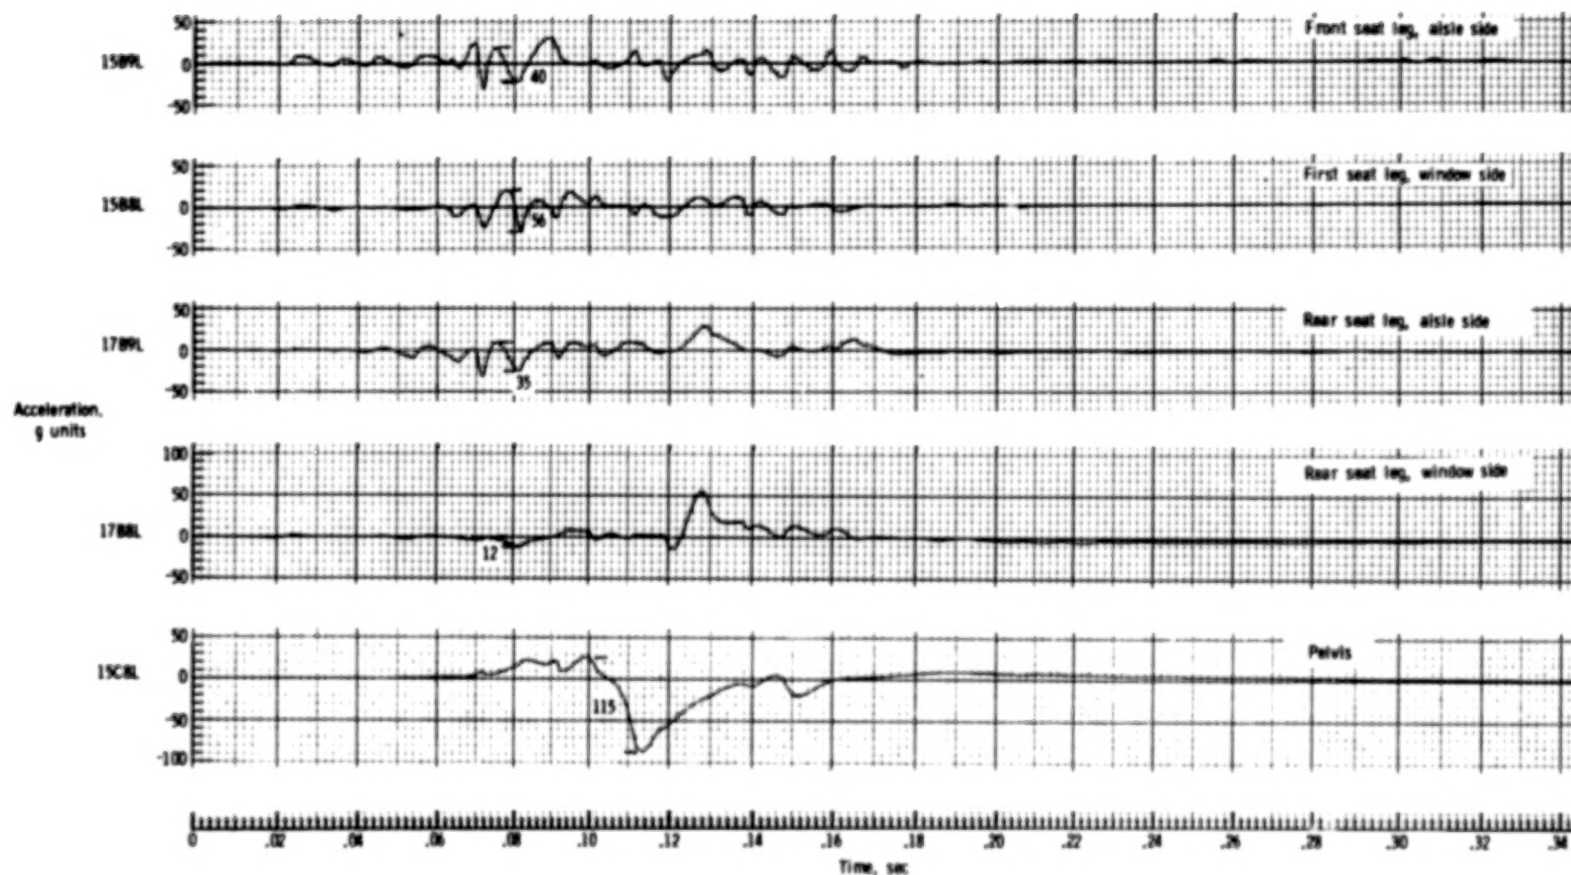
Figure 22.- Longitudinal accelerations on floor and on dummy pelvis at first-passenger location.

Longitudinal accelerations at  $-15^\circ$ . - As shown for the  $-15^\circ$  test specimen in figure 22(a), longitudinal peak-to-peak accelerations of 40g and 50g were recorded adjacent to the front seat legs and 35g and 12g adjacent to the rear seat legs. These acceleration pulses were recorded in the pelvis with a peak-to-peak value of 115g occurring 0.025 sec later.

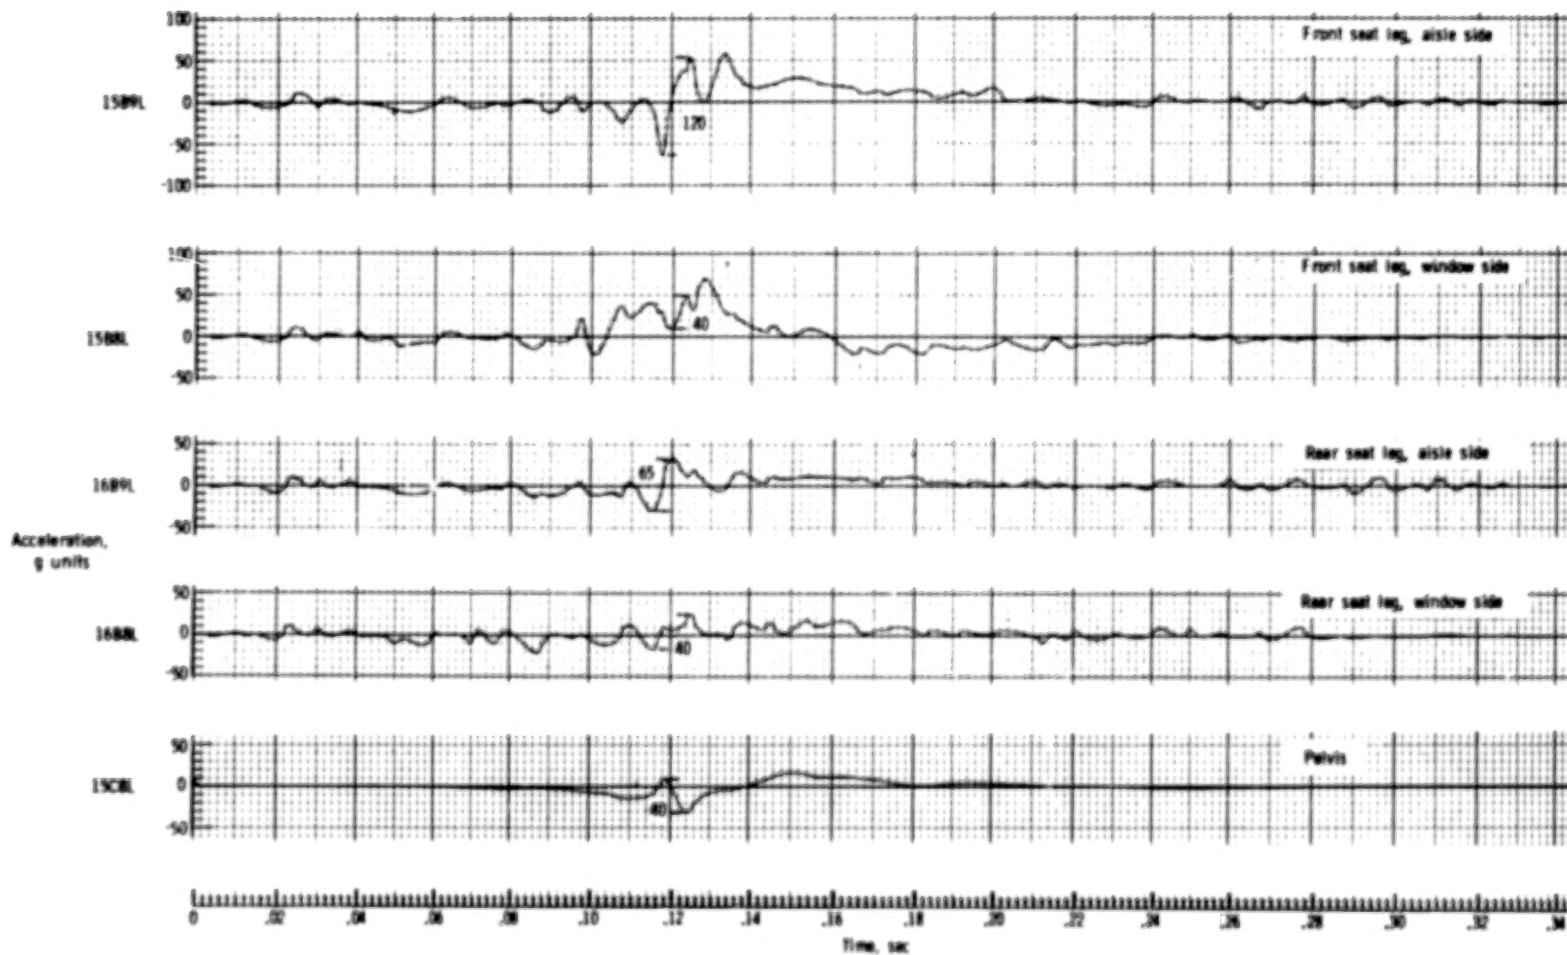
Figure 22.- Continued.

Longitudinal accelerations at  $-30^\circ$ . - As shown for the  $-30^\circ$  test specimen in figure 22(b), longitudinal peak-to-peak accelerations of 120g and 40g were recorded on the floor adjacent to the front seat legs and 65g and 40g adjacent to the rear seat legs. These peaks were recorded in the pelvis as a 40g peak-to-peak pulse occurring 0.025 sec later.
